# KOMPSAT Imagery Quality Report

- KOMPSAT-2, 3, 3A (February ~ March 2020) -

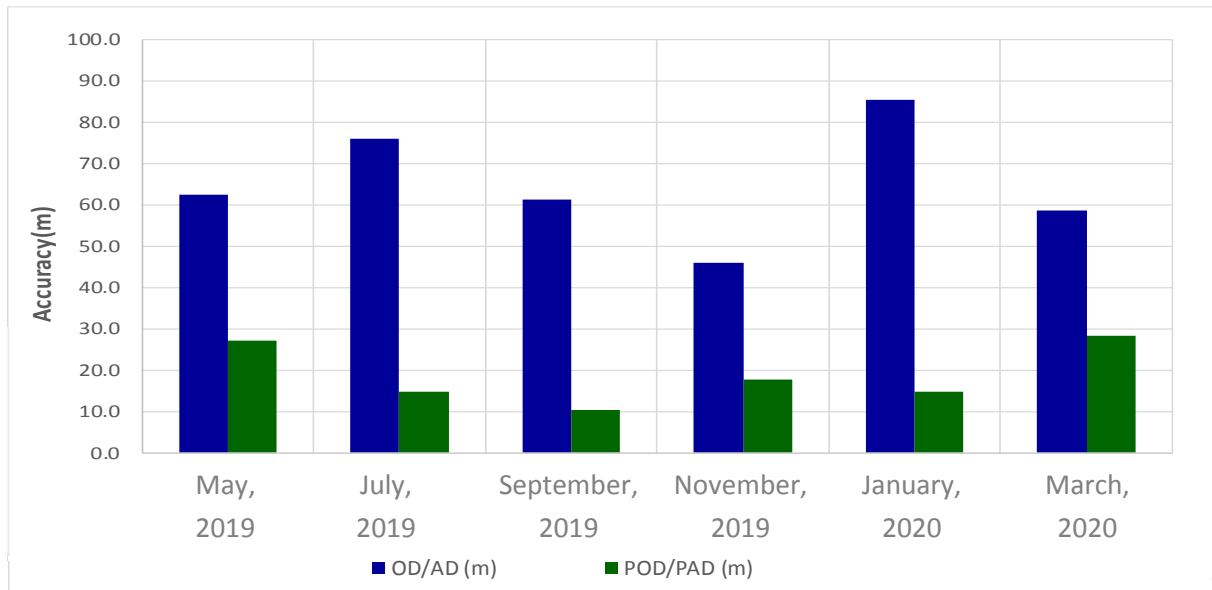
### KOMPSAT-3 Location Accuracy

KOMPSAT-3	28.4m RMSE	10.0%

※ Above location (geometric) accuracy is a result processed with POD/PAD.

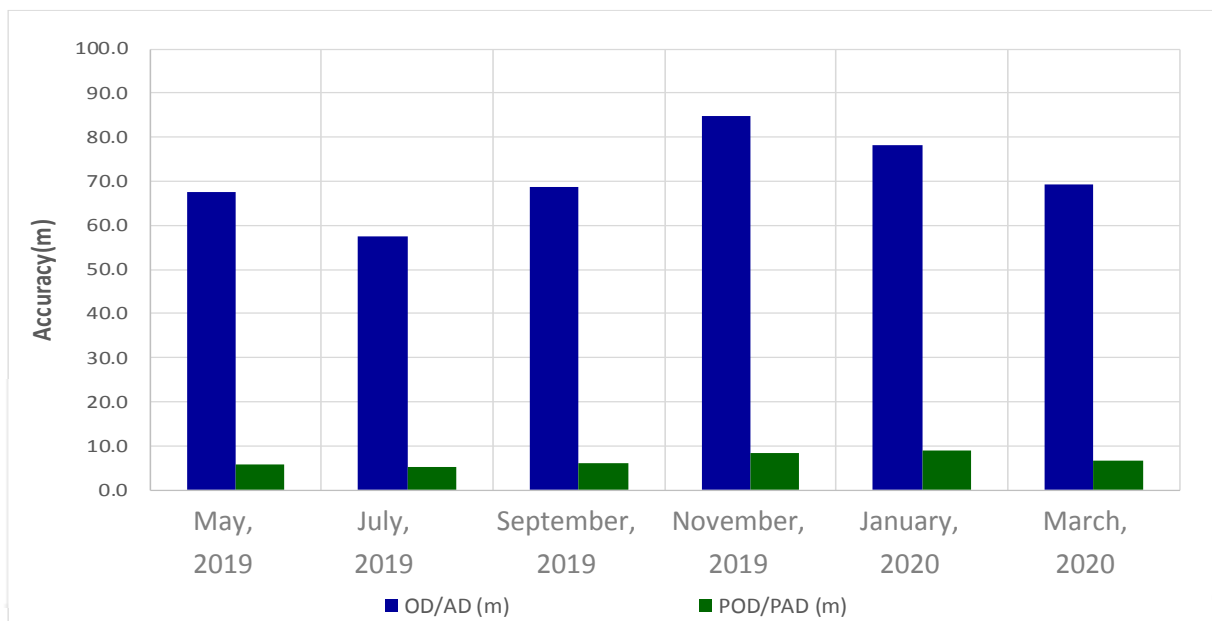
### KOMPSAT-3A Location Accuracy

KOMPSAT-3A	6.7m RMSE	9.6%

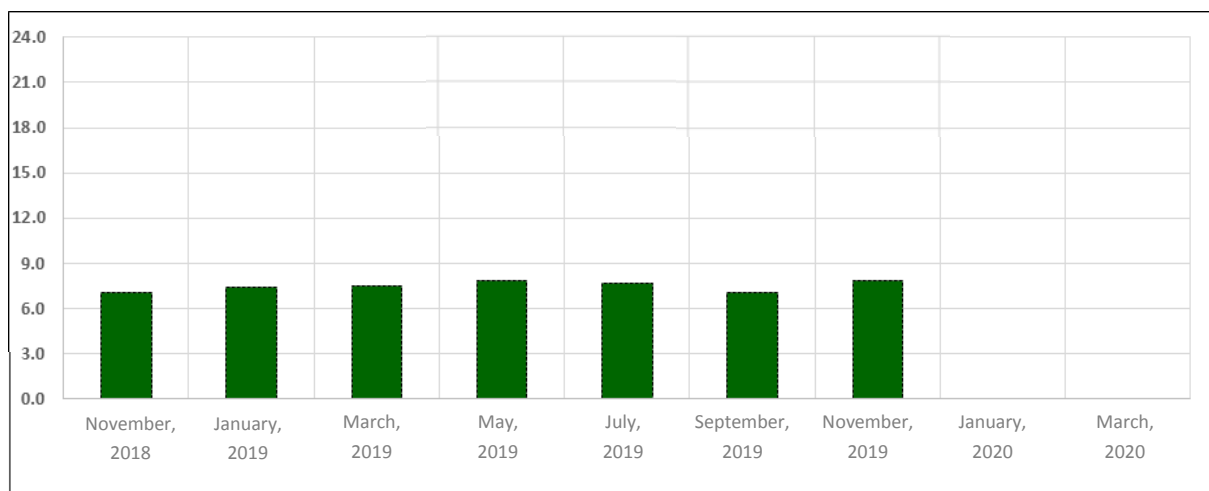
### KOMPSAT-2 MTF

※ Above MTF values are measured with MTFC off.

※ No valid scenes were acquired on January to March 2020.
